Hackman Lateral - An Acequia (irrigation ditch) Tierra Viva Homeowners Obligation General Explanation

WHERE DO THINGS STAND WITH THE ACEQUIA?
UPDATED JANUARY 2020.

Where we are at the present, January 2020.

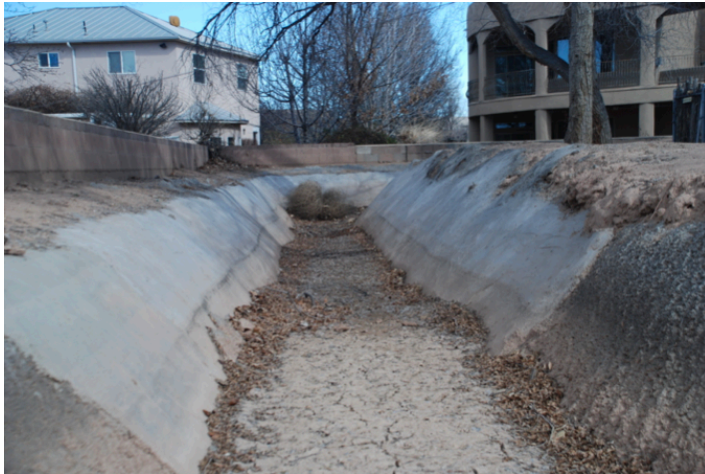
Repaired sidewall in foreground, original gunnite downstream

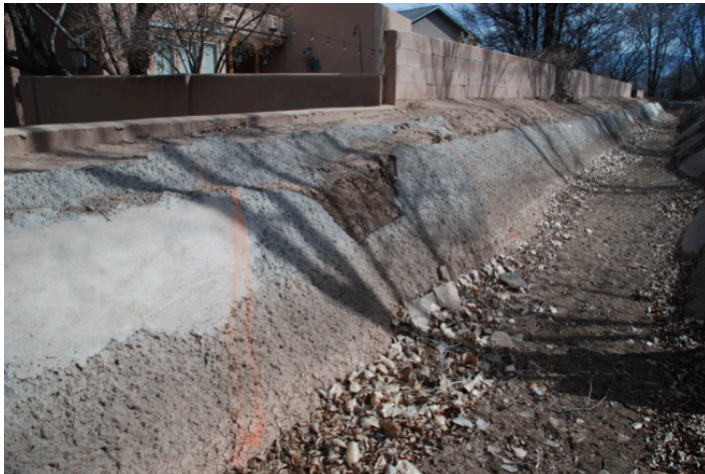
Example of sidewall failure, previous patch. Area inside orange line Replaced entirely.

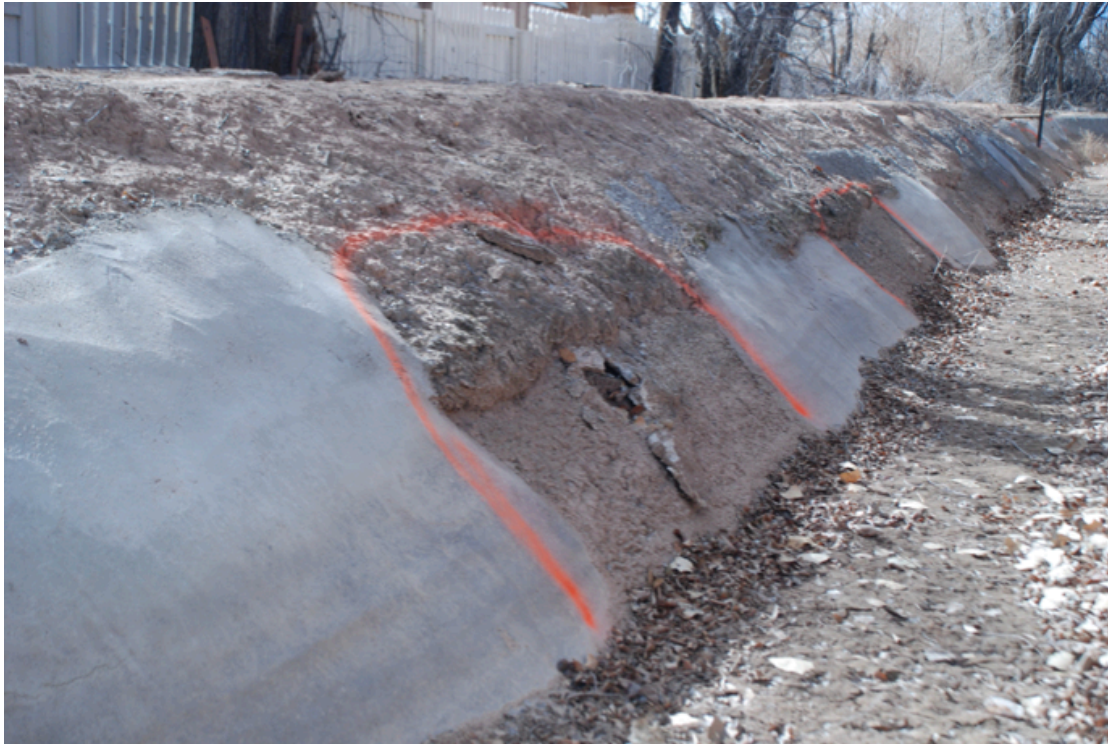
Sample of failure between patches, under more aggressive repair program areas between patches when a failure is discovered entire area between patches is replaced.

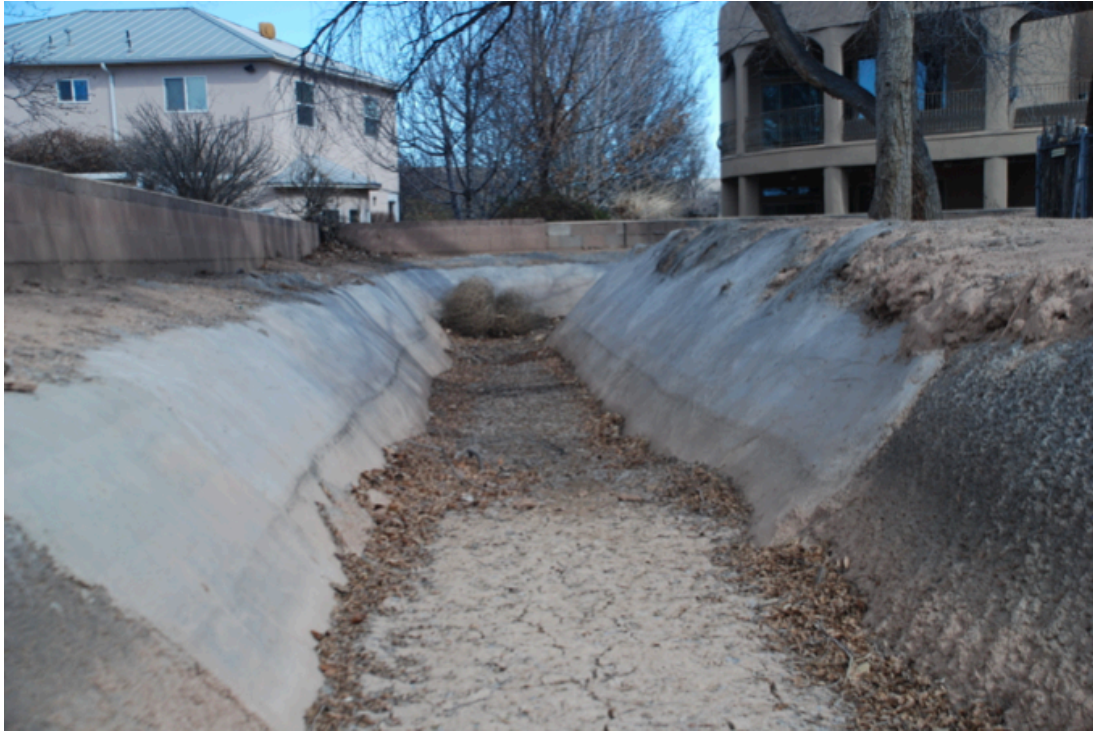
Example of a large repair replacing piecemeal patching

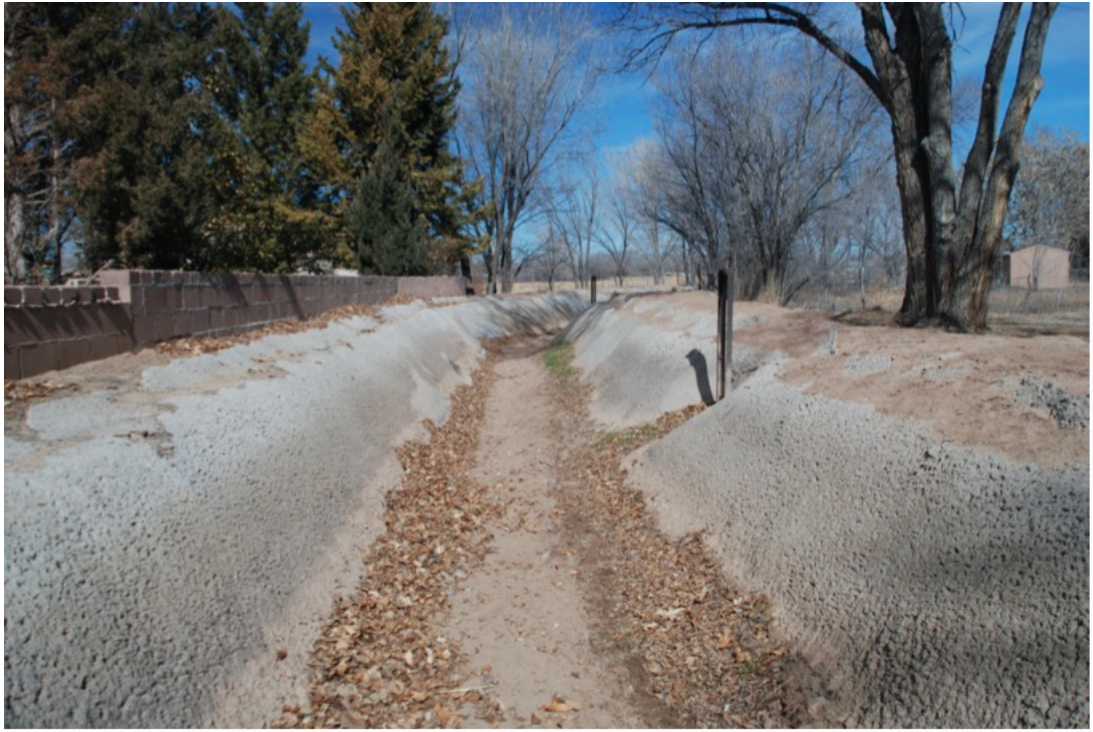
Example of original gunfire application still in serviceable condition. Below is an example of a burrowing animal undermining the ditch. Seasonal changes are animal control and weed abatement.

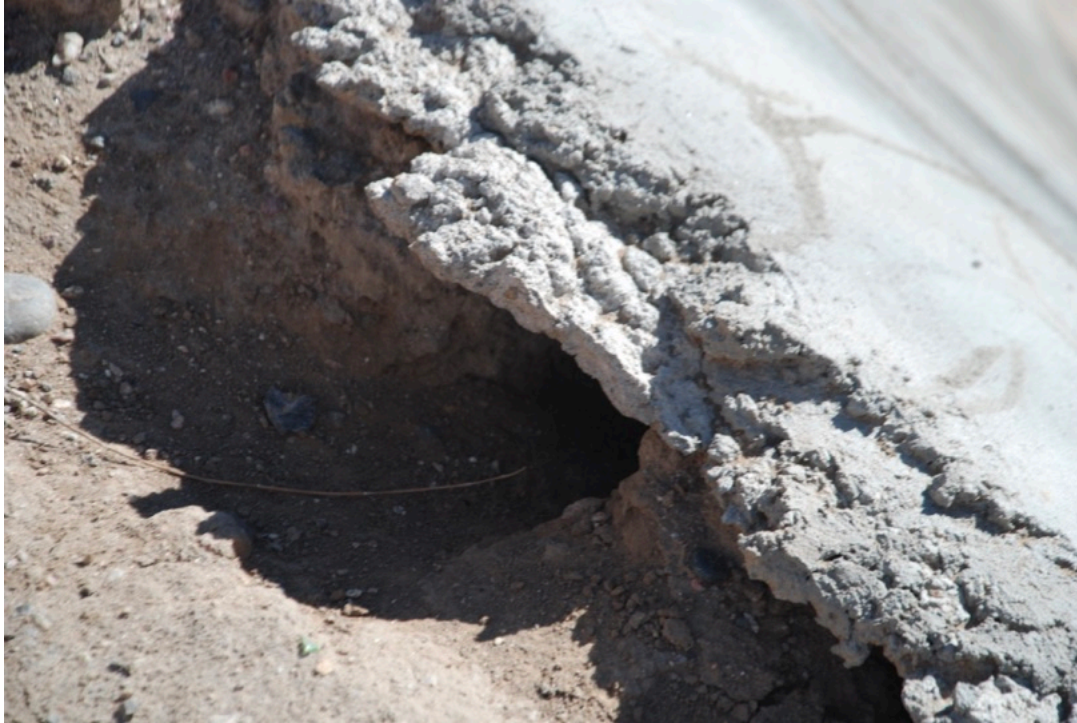
Finally, there is evidence of animal tunneling around the ditch, which if left unchecked could undermine the ditch and cause partial collapse. The Board continues to focus on these challenges. A hopeful element: We hope and expect that replacing the failing or failed wall sections aggressively with waterproofed concrete will reduce repair work that must be done in future. That could in time lead to a reduction in the annual HOA assessment.
